**Sugarbush Elementary**

**Mechanical and Electrical  
Systems Due Diligence & Feasibility  
Report**

**February 2, 2024**

**PBA Project No. 2023.0428.00**

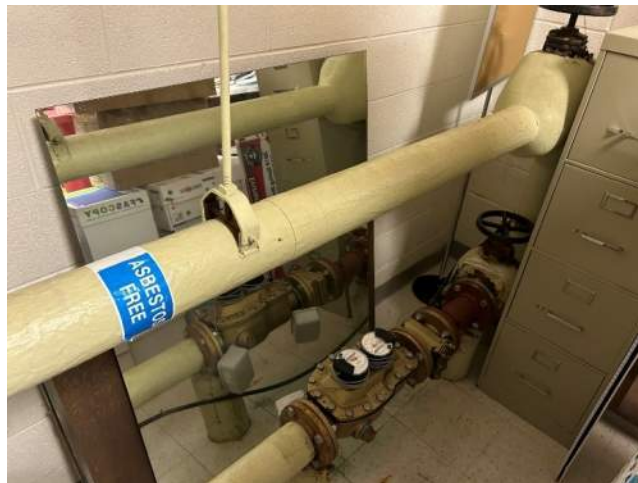
Photo 1: Domestic Water Service

- Domestic water piping from service entrance is routed into the main corridor and then splits to serve the entire building.
- A water meter is located in a storage room in the Administration area.
- The domestic water service is not provided with a backflow prevention device.
- The water service is provided with a valved bypass.
- The domestic cold water main is insulated and therefore the piping material could not be verified.

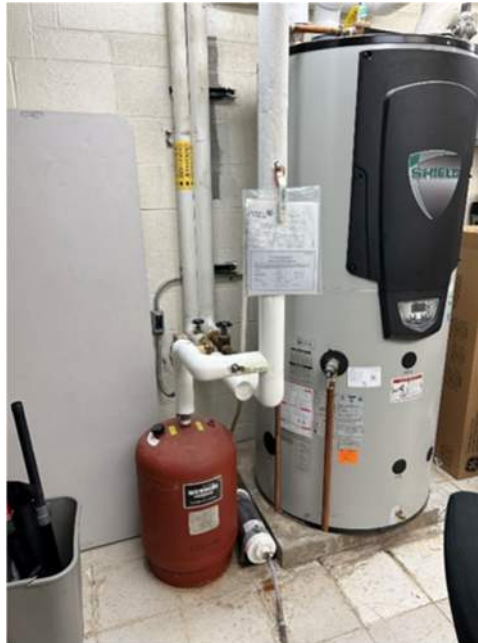
Photo 2: Domestic Hot Water Heater

- The building is equipped with a high efficiency gas fired water heater located in the storage room below the boiler room.
- The domestic hot water heater serves the plumbing fixtures throughout the building and the main kitchen.
- The domestic hot water and hot water return piping appears to be copper with soldered joints.
- The piping was insulated with fiberglass insulation in the areas that were visible.
- The hot water return system was equipped with an in-line circulating pump.

- The domestic hot water heater is in good condition.
- The condition of the hot water piping throughout the building is unknown, but it is assumed that any new piping near the water heater is in good condition.
- The hot water and hot water return piping is insulated.
- Township staff noted there are no problems with the hot water or hot water return system.

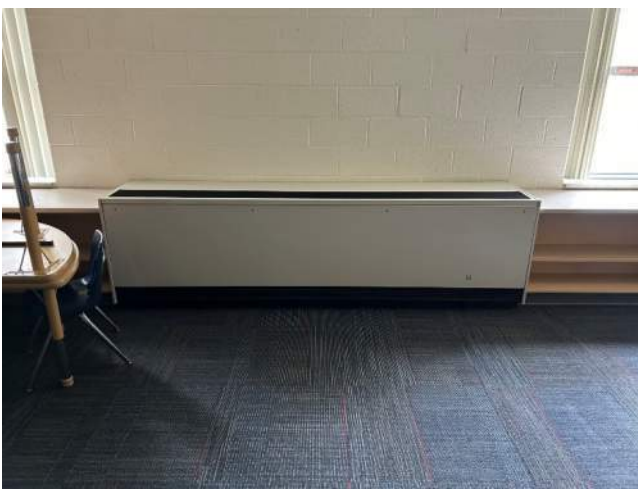
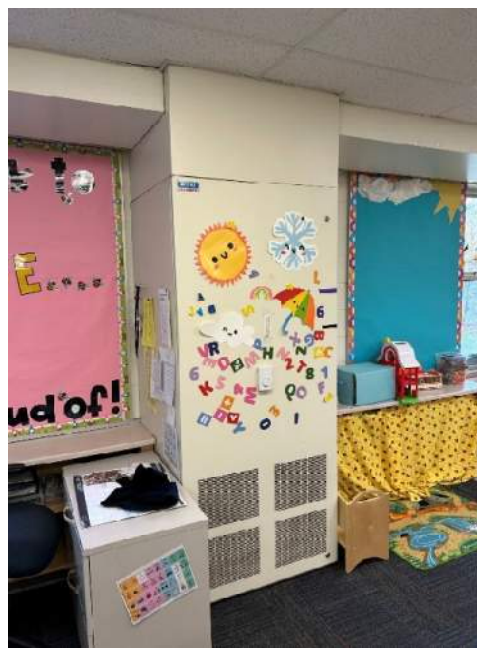
Photo 3: Horizontal Unit Ventilator

Photo 4: Vertical Unit Ventilator

- The original units have exceeded their useful service life.
- The air distribution in the original classrooms based on the unit design is poor.
- The VUV's added in the early 2000's are in fair condition; however they have also exceeded their useful service life.
- The overhead distribution system provides a better environment for occupants than the original units.

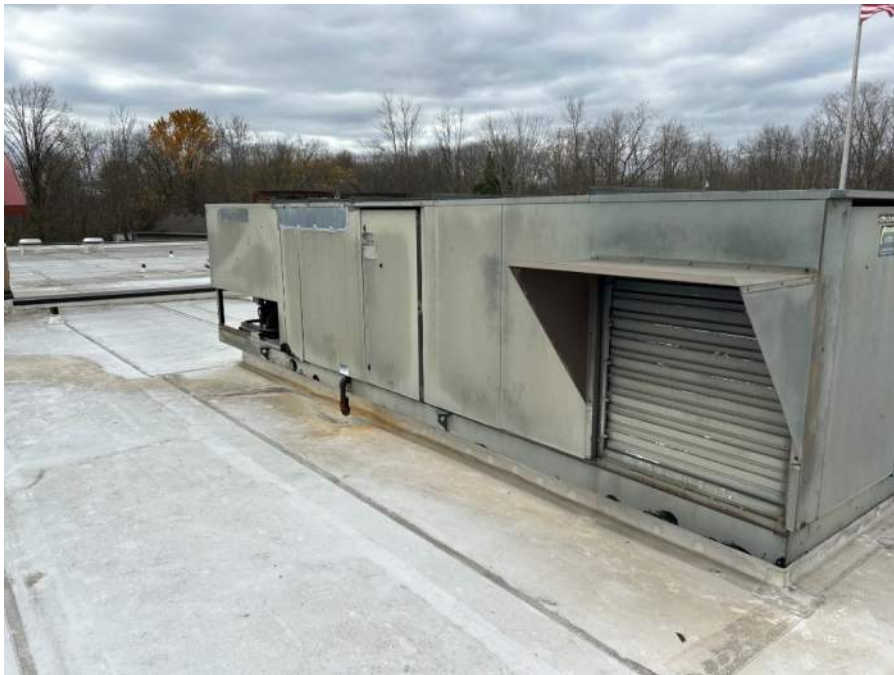
Photo 5: Packaged Rooftop Unit serving Administration

- The Mammoth unit is original and has exceeded its useful service life.
- The multi-zone system although very popular in the 1970's is not energy efficient.
- The dampers that modulate for each zone over time fail and the parts are difficult to maintain causing poor occupant comfort.
- The overall condition of the unit is poor due to age and exposure to the elements for over 45 years.

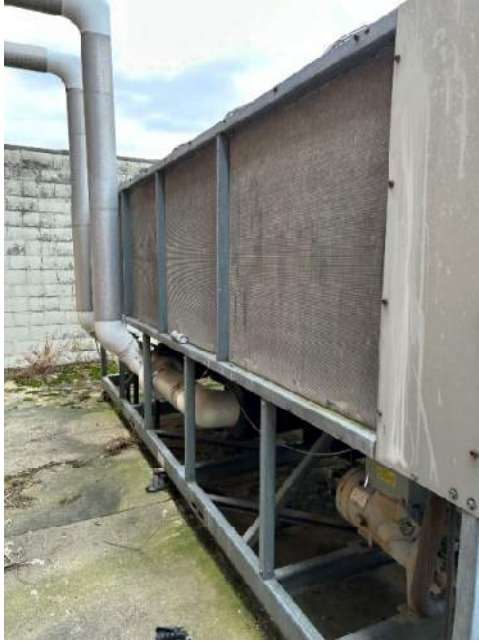
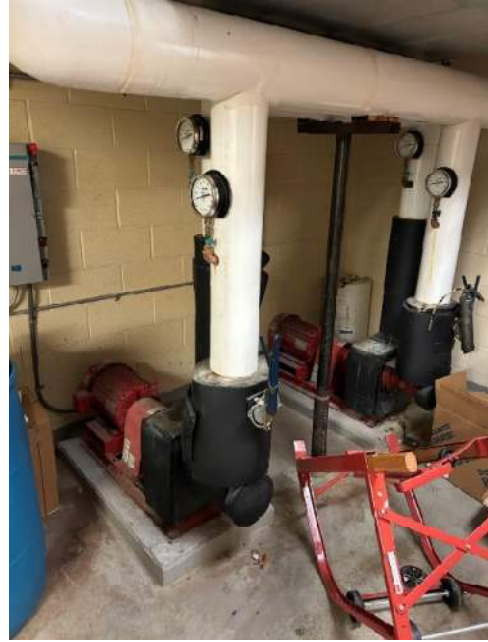
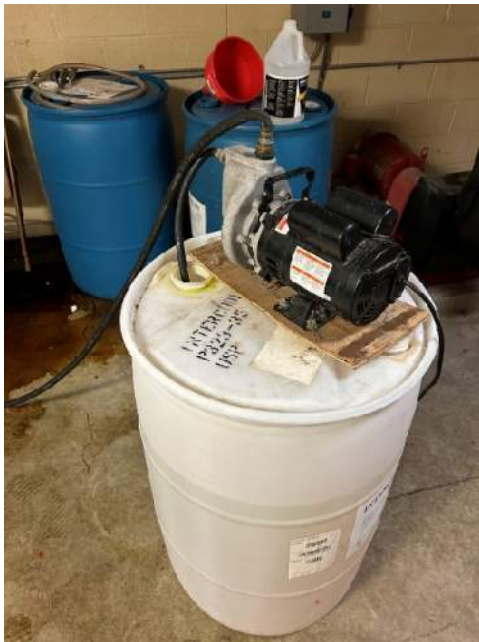
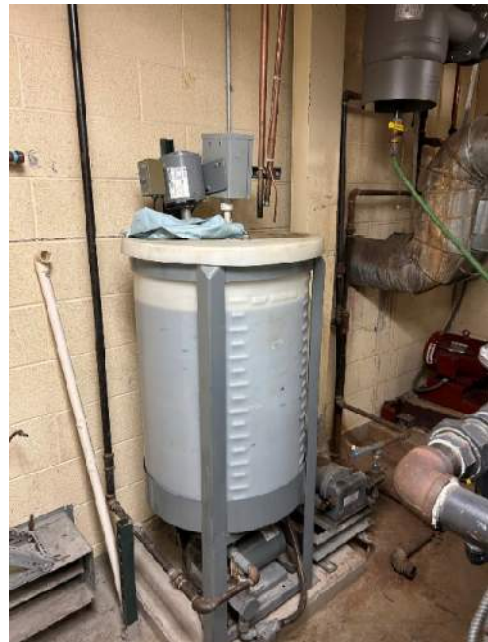
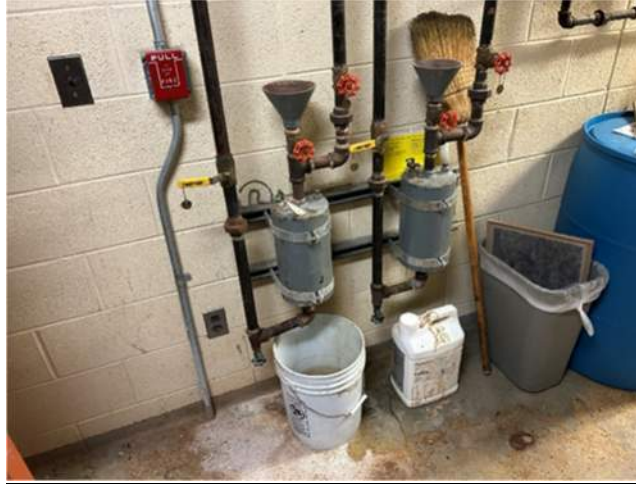
- The building is provided with a Trane air cooled chiller located on grade surrounded by a masonry enclosure.
- The chiller is approximately 100-120 tons, nameplate data was weathered and not legible.
- Chilled water piping is extended throughout the building and connected to unit ventilators located throughout the school.
- Glycol is injected into the chilled water system to prevent freezing during the winter.
- The chilled water system is equipped with two base mounted circulating pumps, expansion tank, and chemical shot feeder.
- The chilled water system appears to be constant volume.

Photo 6: Air Cooled Chiller

- The chiller appears to be installed in 2001 and is approximately 23 years old based on the minimal amount of information from the compressor nameplate.
- The chiller is utilizing R-22 refrigerant which is not produced anymore and is very costly to fill in the event of a leak.
- The chilled water system is operating in a constant volume arrangement, which is not energy efficient.
- Due to the piping arrangement the glycol solution is being pumped throughout the school, resulting in reduced system capacity and additional pumping power.
- During our site investigation it was noted the chiller has been experiencing more and more service calls.
- Township staff noted that they would like to eliminate the chilled water system and go to packaged rooftop units to reduce operating costs and maintenance costs.

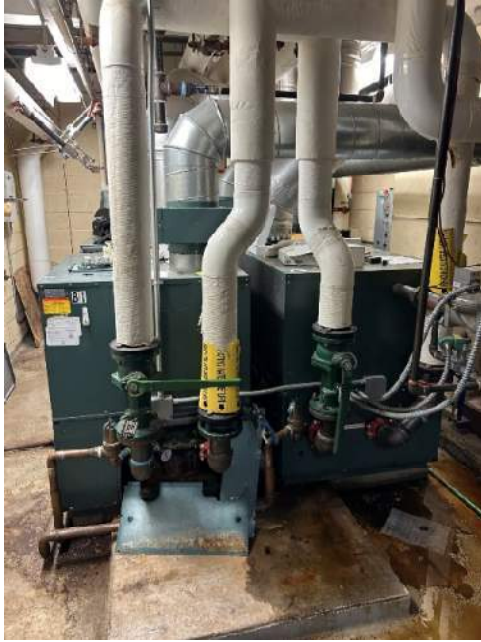
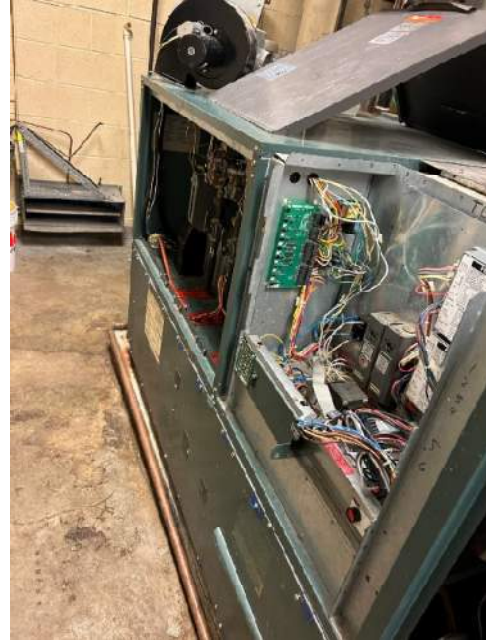
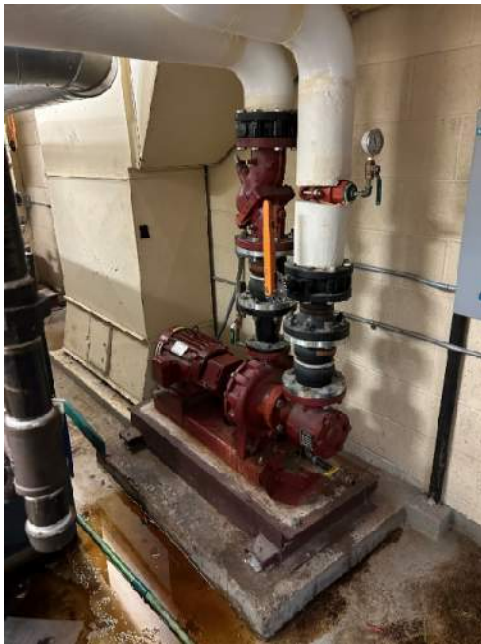
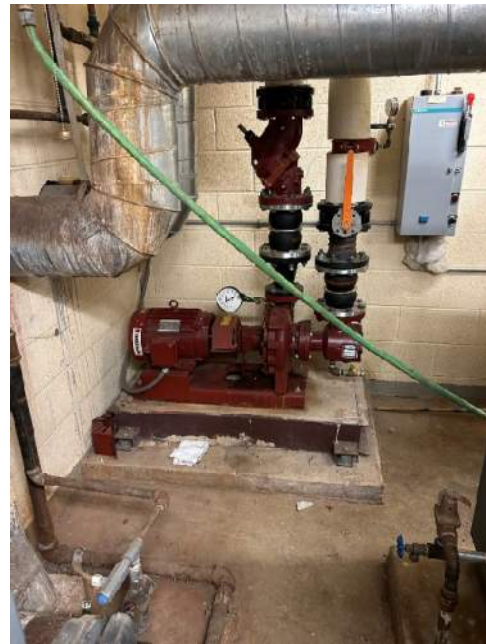
Photo 11: Hot Water Heating Boilers

Photo 12: Hot Water Heating Boiler

- Only one boiler is operational and the other boiler has been used for parts.
- The boilers are over 20 years old and have exceeded their useful service life.
- Overall, the boilers appear in poor condition.
- The State of Michigan Boiler Certificate indicates the last year it was inspected was 2020.
- The heating system piping in the boiler rooms has signs of leaks.
- The staff did not report any issues with the heating system.

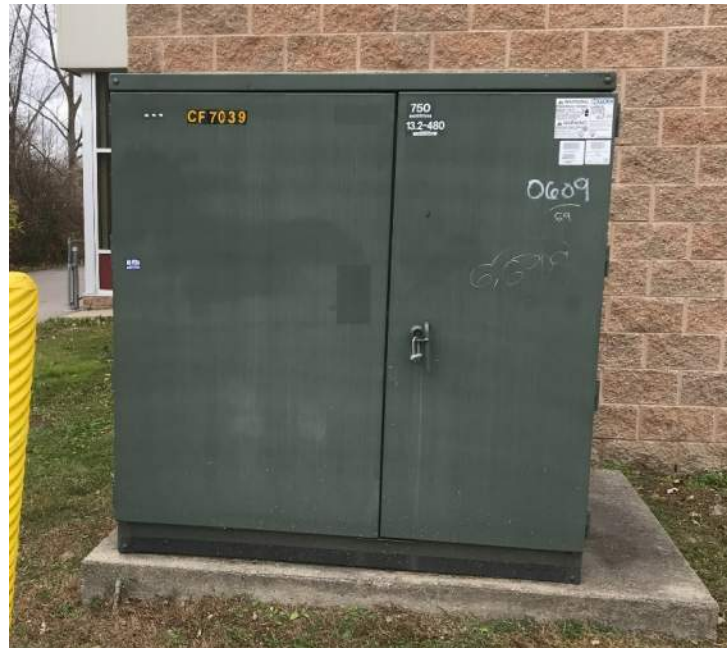
The electrical service for the building is provided by DTE Energy. There is a 750 kVA 13.2kV-480/277V pad-mounted transformer located on the exterior of the building near the main electrical room.

Photo 15: Pad Mounted 750 kVA Utility Transformer

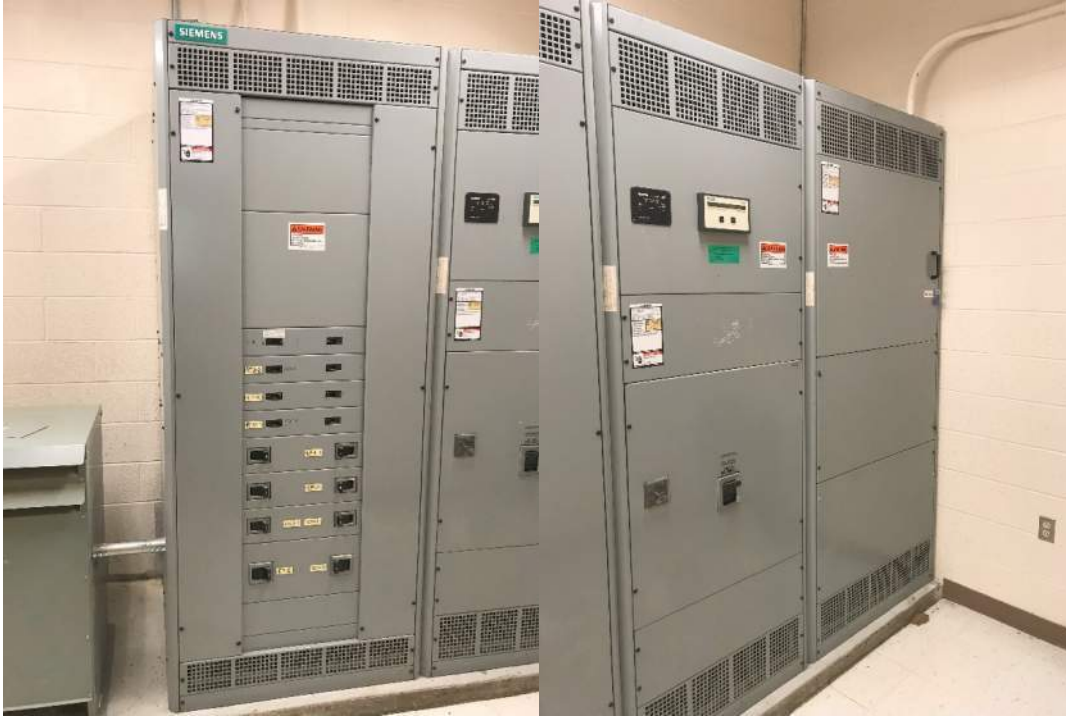
Photo 16: Main Switchboard

The 1200A main switchboard (MSB) is located in the southern corner of building and services the entire building.

The equipment is approximately 24 years old.

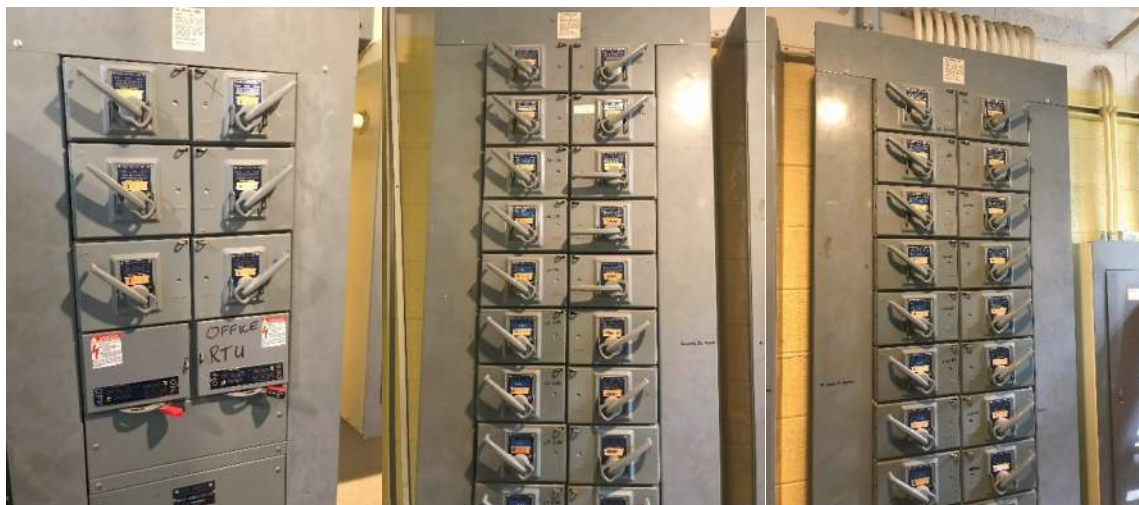
This equipment is approximately 49 years old.

The only code violation noted was the room being used for storage within the clearance area of the electrical equipment.

Photo 17: Library and Community Center Electrical Room (DP-2, DP-4, DP-3 respectively)

- *Perform a short circuit, coordination and arc flash hazard analysis and provide appropriate arc flash hazard labels on all distribution equipment.*
- *Replace fluorescent lamps with LED lamps or replace light fixture entirely to lower energy usage.*
- *Test emergency lighting and replace all batteries or fixtures that are not operational.*
- *Remove storage items from the clear space required in front of electrical equipment.*

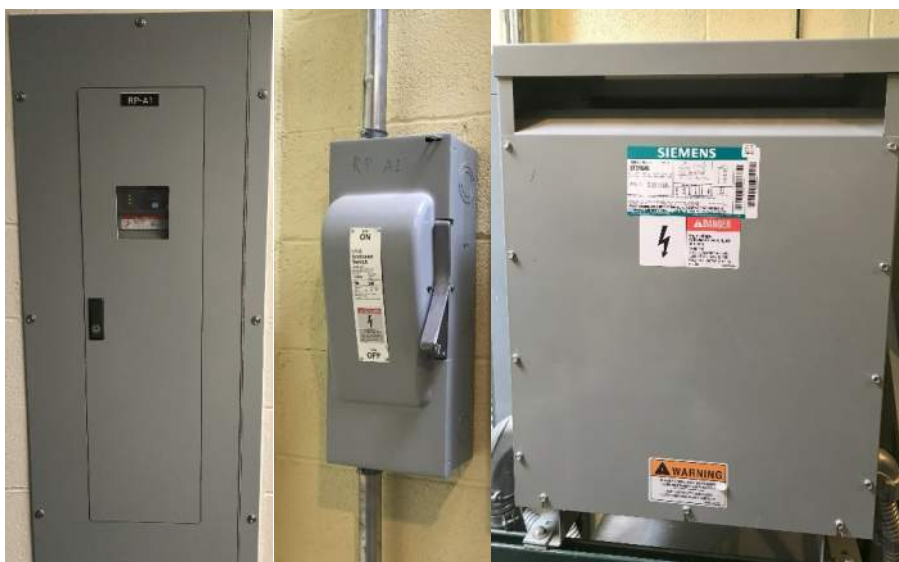
1. RP-A1: 100A MLO 208Y/120V 3 phase 4 wire panelboard via 45kva transformer (T-A1) secondary side. This equipment is approximately 20 years old.

Photo 18: RP-A1 (Panel RP-A1, Disconnect, T-A1 respectively)

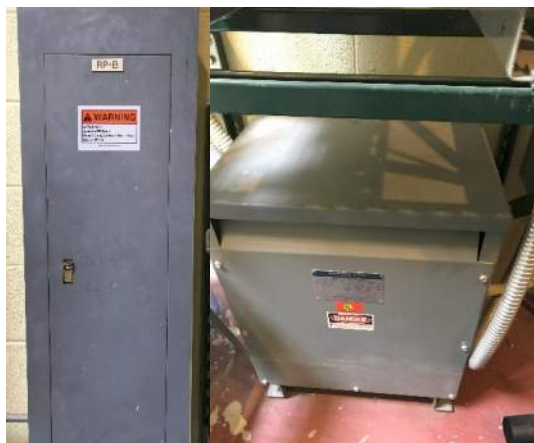
2. RP-B: 225A MCB 208Y/120V 3 phase 4 wire panelboard via 45kva transformer (T-B) secondary side. This equipment is approximately 49 years old.

Photo 19: RP-B (Panel RP-B, T-B respectively)

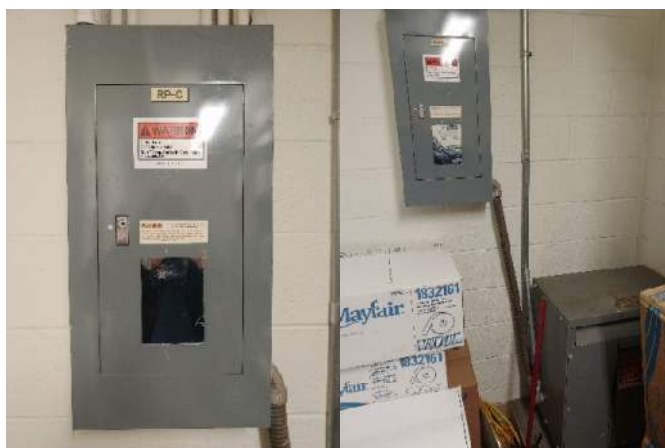
3. RP-C: 100A MCB 208Y/120V 3 phase 4 wire panelboard via 30kva transformer (T-C) secondary side. This equipment is approximately 49 years old.

Photo 20: RP-C (RP-C, T-C respectively)

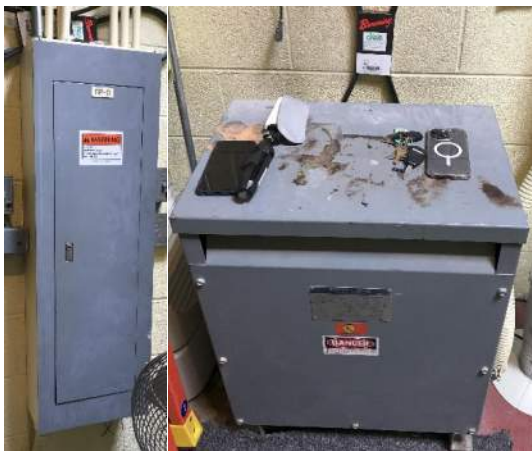
4. RP-D: 225A MCB 208Y/120V 3 phase 4 wire panelboard via 45kva transformer (T-D) secondary side. This equipment is approximately 49 years old.

Photo 21: RP-D (Panel RP-D, T-D respectively)

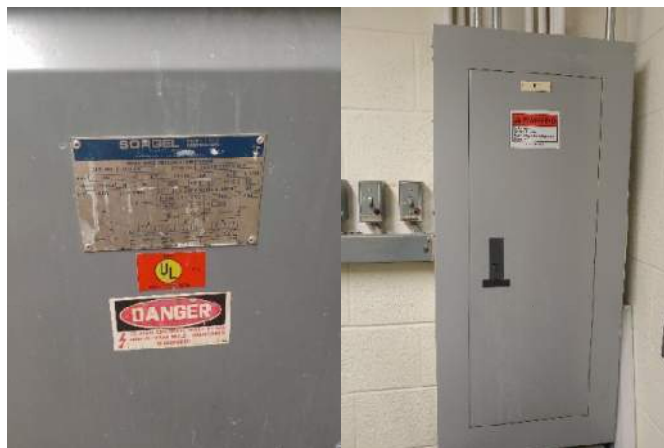
5. RP-E: 100A MCB 208Y/120V 3 phase 4 wire panelboard via 30kva transformer (T-E) secondary side. This equipment is approximately 49 years old.

Photo 22: RP-E (T-E, RP-E Respectively)

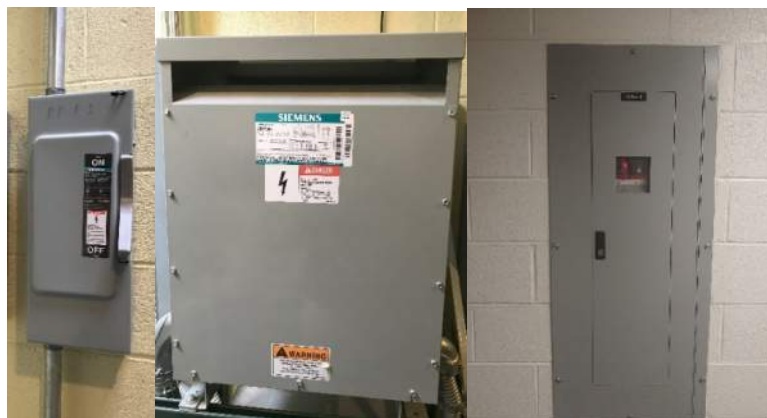
6. RP-F1: 100A MLO 208Y/120V 3 phase 4 wire panelboard via 45kva transformer (T-A1) secondary side. This equipment is approximately 20 years old.

Photo 23: RP-F1 (Disconnect, T-A1, RP-F1 respectively)

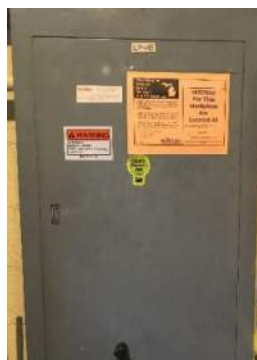
Photo 24: LP-HB

7. LP-HB: 100A MLO 480Y/277V 3 phase 4 wire panelboard. This equipment is approximately 49 years old.

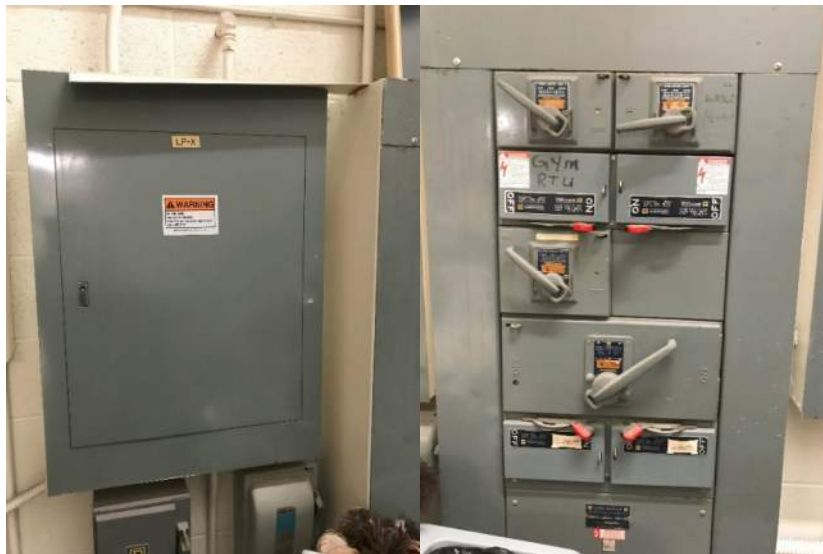
Photo 26: LP-X and DP-1

The electrical service for the community center portion of the building and building wide night lightings is distributed via a 400A MLO 480Y/277V 3 phase 4 wire distribution panel DP-1 and a 100A MLO 480Y/277V 3 phase 4 wire distribution panelboard LP-X (both added in 1974). DP-2 and LP-X are both fed from the MSB. This equipment is approximately 49 years old.

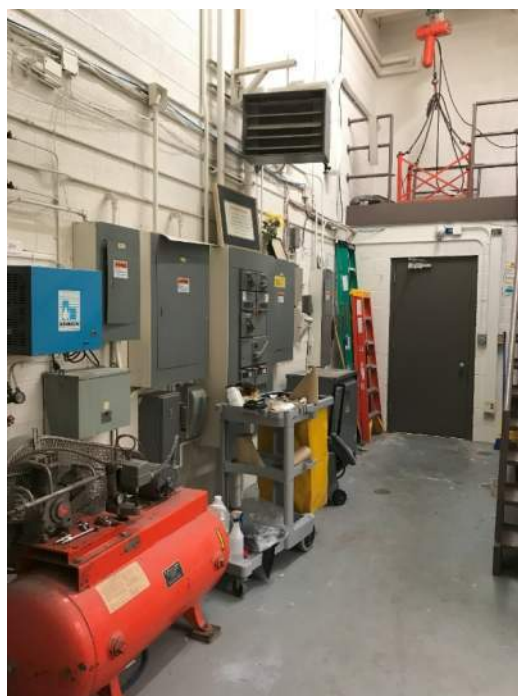
The only code violation noted was the room being used for storage within the clearance area of the electrical equipment. This equipment is approximately 49 years old.

Photo 27: Main Community Center Electrical Room

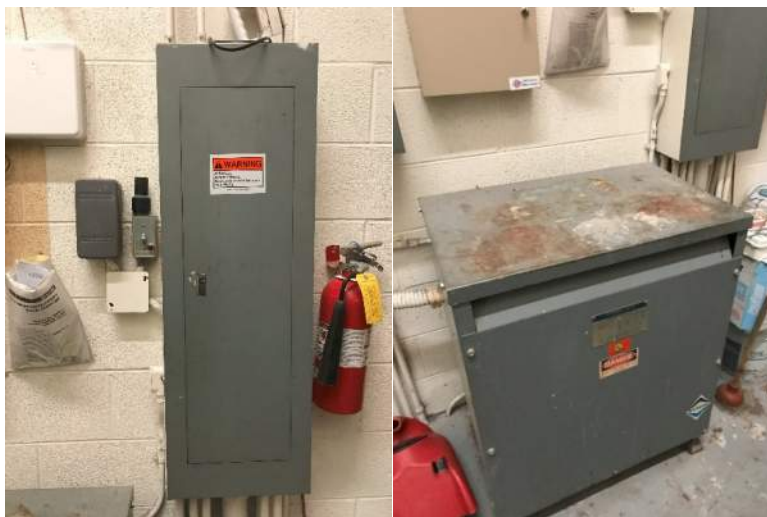
Panel RP-A 225A MCB 208Y/120V 3 phase 4 wire panelboard is fed via secondary side of floor mounted 75KVA transformer (T-A) the primary side is fed from DP-1. This equipment is approximately 49 years old.

Photo 28: RP-A (RP-A, T-A respectively)

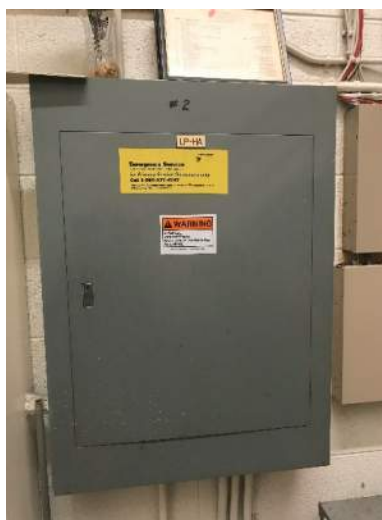
Photo 29: Panel LP-HA

Panel LP-HA 100A MLO 480Y/277V 3 phase 4 wire panelboard is fed from DP-1. This equipment is approximately 49 years old.

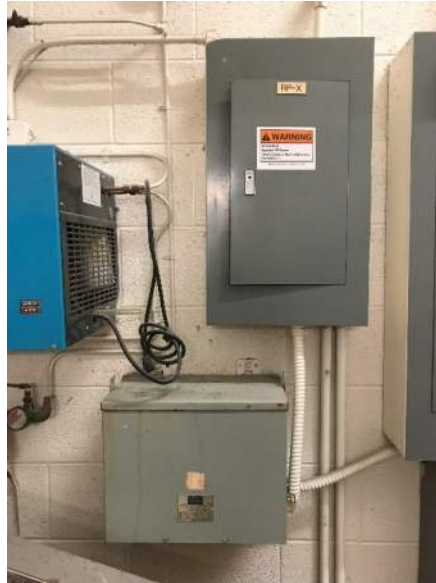
Panel RP-X MCB 100A 208Y/120V 3 phase 4 wire panelboard is fed via secondary side of wall mounted 9KVA transformer (T-X) the primary side is fed from LP-X.

This equipment is approximately 49 years old.

Photo 30: Panel RP-X and Transformer T-X

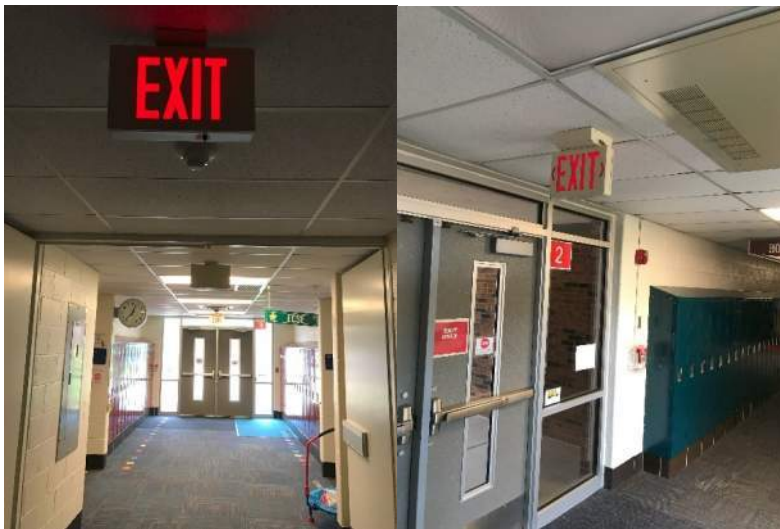
Emergency lighting is provided by emergency battery units (EBU's) in exit signs and night light fixtures wired ahead of local control. No generator or related alternate power available onsite. EBU's generally appear in good condition and appear to be from the renovation in 2004.

Photo 31: Typical Corridor EBU/Exit Sign

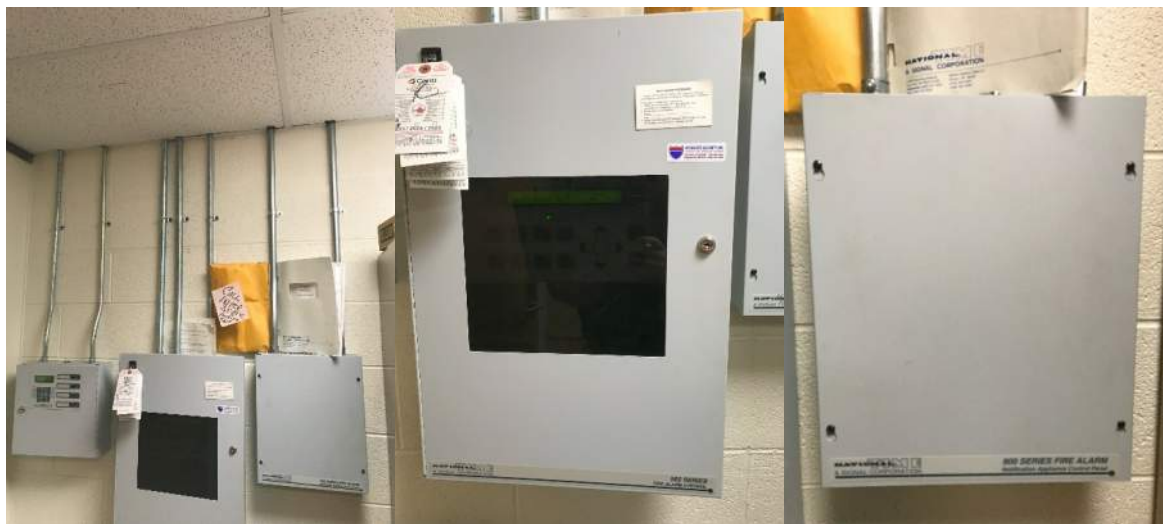
The fire alarm control panel and system devices appear to be new and in good condition. The panels are Central Station Fire units – 900 series by National Time and Signal Corporation. It appears to have been recently serviced/tested by Chesterfield Township Building Department. Activation of the system is by manual pull stations.

Photo 32: Existing Fire Alarm Panel

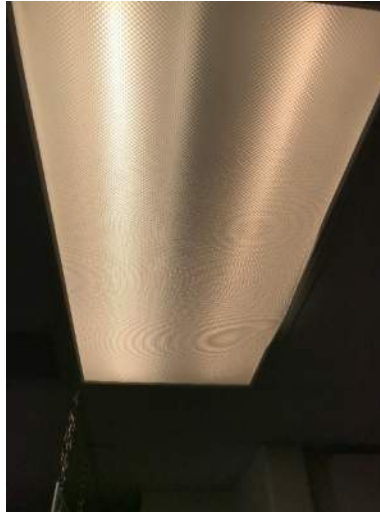
Lighting in the corridors and the classrooms is provided by two-foot (2') by four-foot (4') troffer lights with fluorescent bulbs. The lights appear to be in good condition and were installed in 2004.

Photo 33: Typical Corridor and Classroom 2x4 Troffer Light
