**Sugarbush Elementary**

**Mechanical and Electrical  
Systems Due Diligence & Feasibility  
Report**

**February 2, 2024**

**PBA Project No. 2023.0428.00**

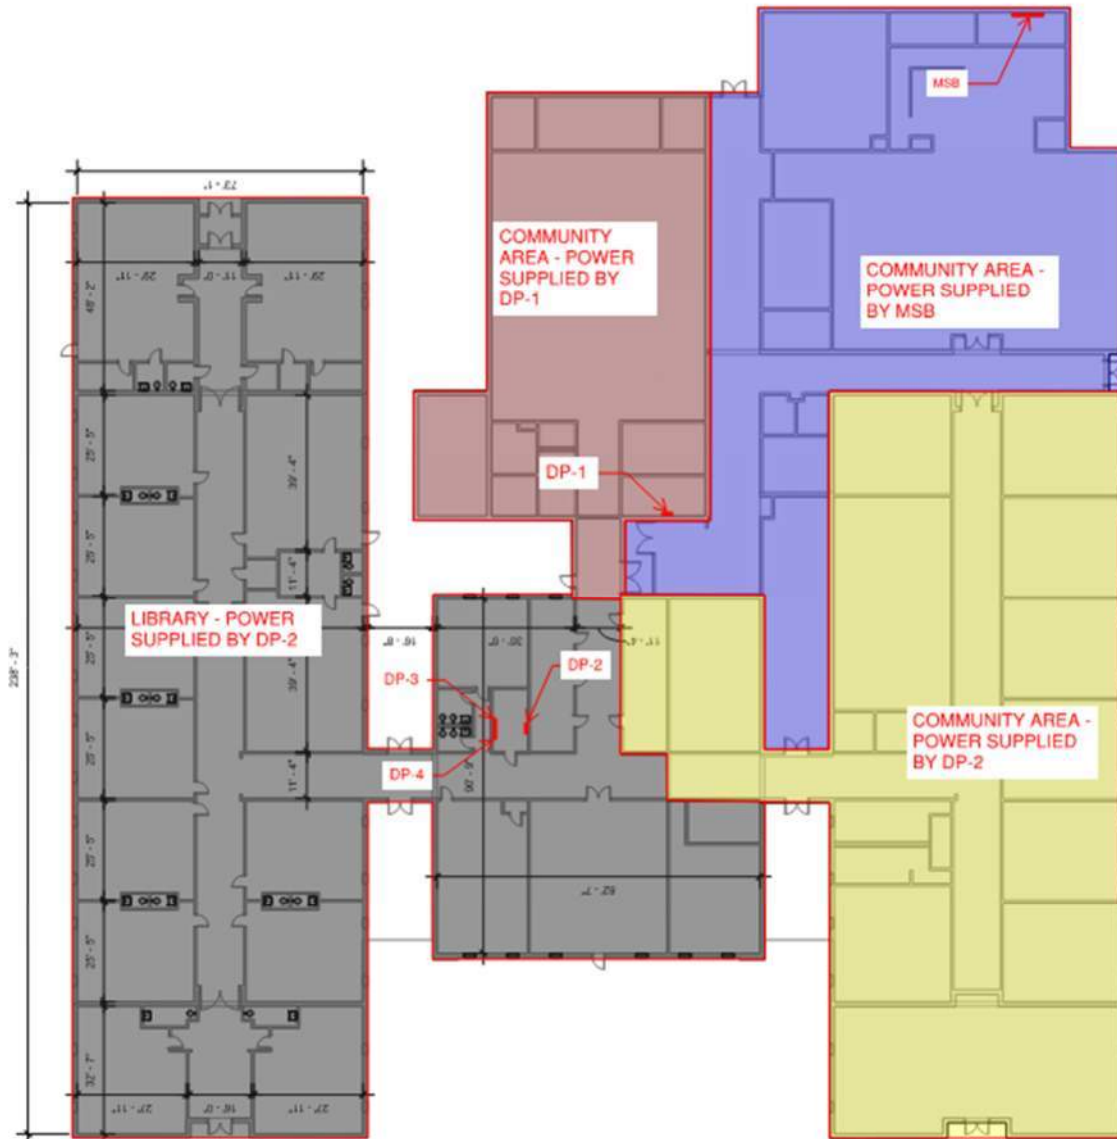
Figure 1: Sugarbush Light, Receptacle, and Misc. Power Distribution Zones.

The branch circuit distribution observed appeared to be installed with code compliant wiring methods. Panelboards are original to the building and are in good condition. There are two main electrical rooms containing panelboards with distribution panels DP-1, DP-2, DP-2, and DP-4 as shown below. There is also various panelboards and transformers located throughout the building in miscellaneous rooms. Dry type transformers, including primary transformers, are approximately 20-49 years old. The original electrical equipment is past the end of their expected service life, but they may continue to operate without issues.
